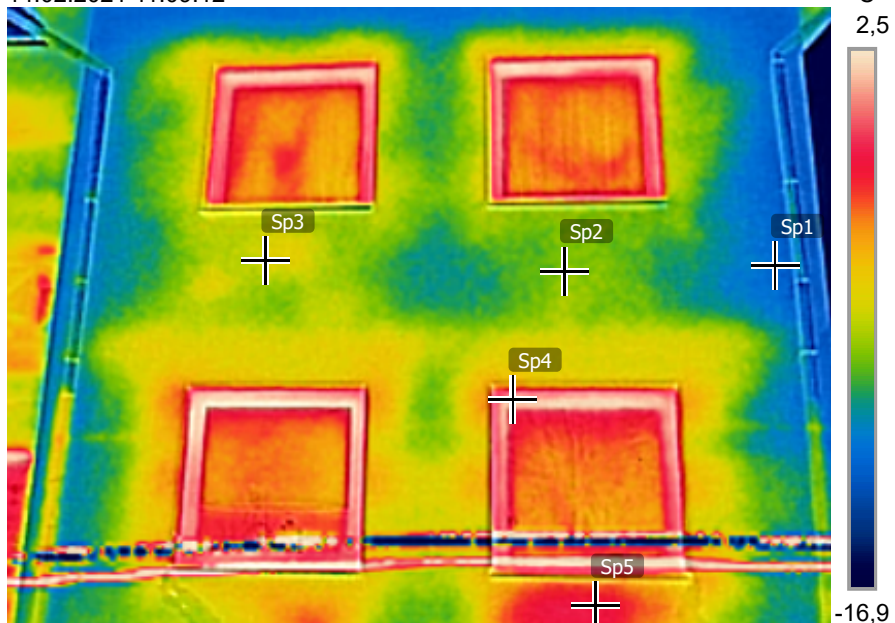
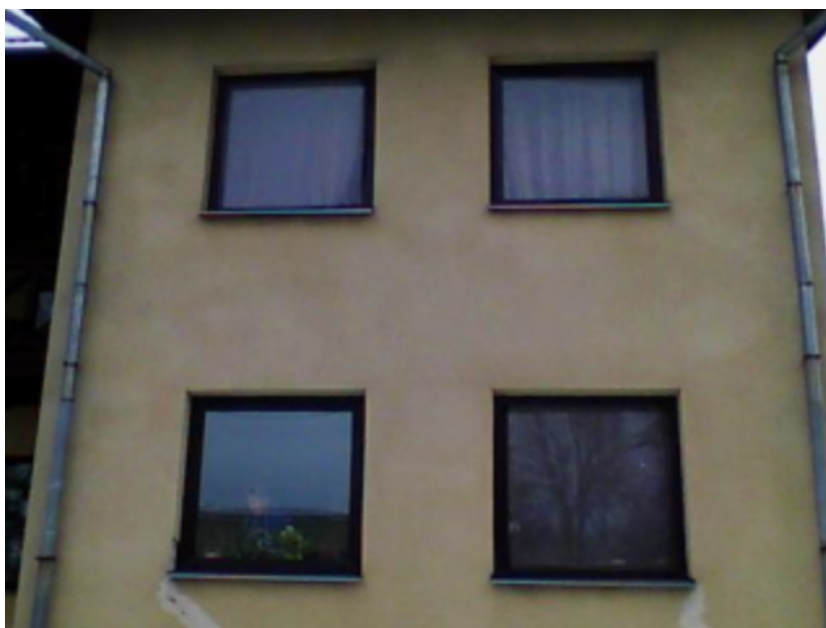
Köögi aknad I korrusel

Krislini tuba vasakul II korrusel, Ly tuba paremal II korrusel.

Sp2 ja Sp3 kütavad radiaatorid, Sp4 köögi aknaraam, Sp5 küttev radiaator.

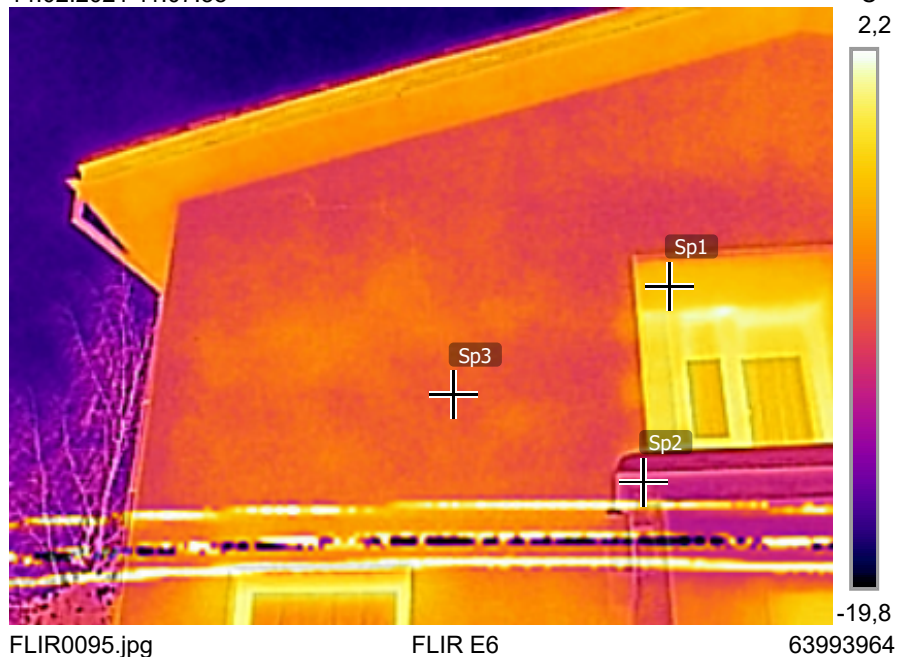
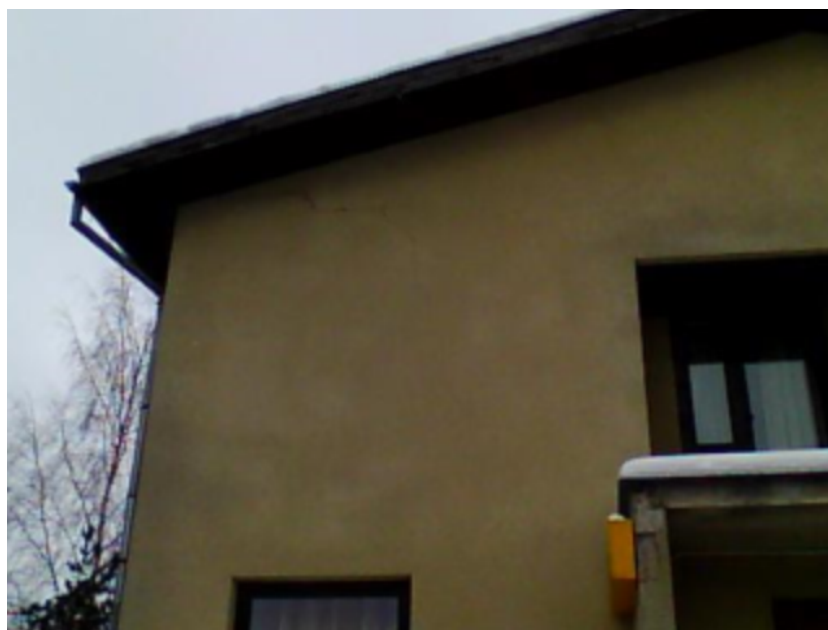
Köögi lagi ja Ly toa sein II korrusel + II korruse rõdu uks.

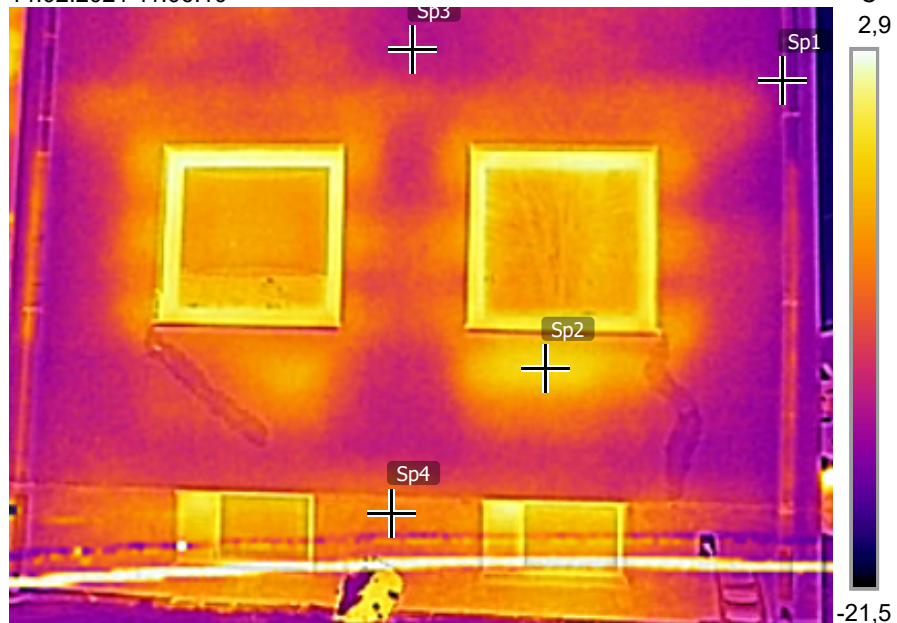
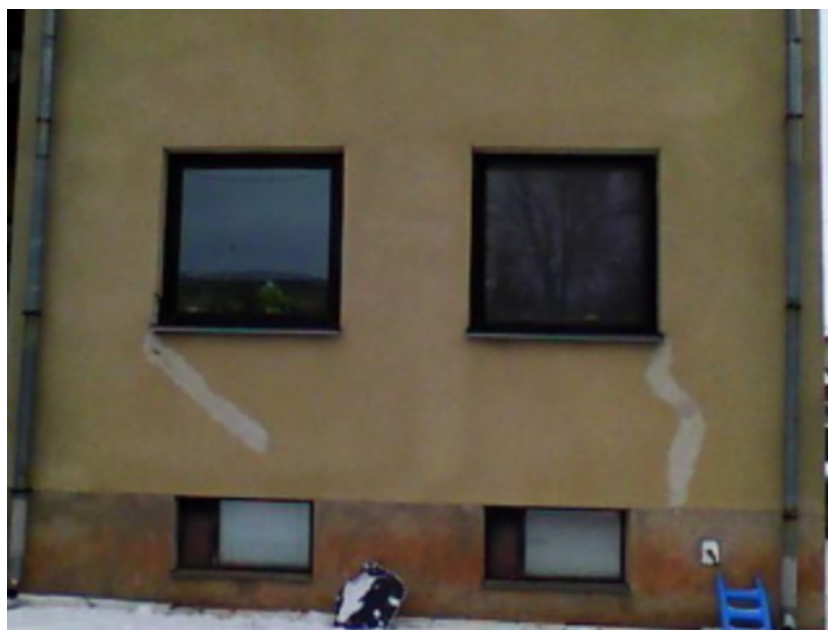
Köögi aknad I korrusel ning sauna akand soklil.

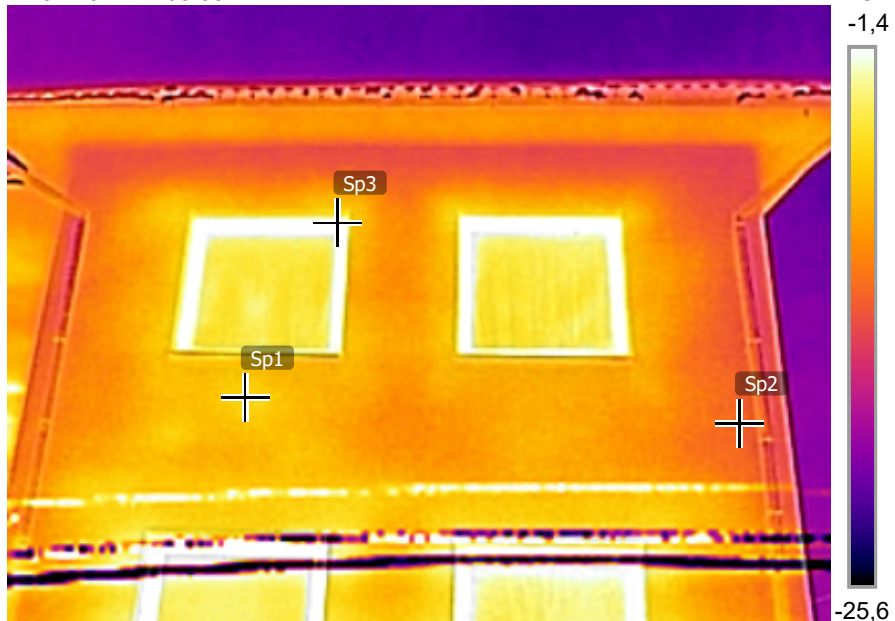
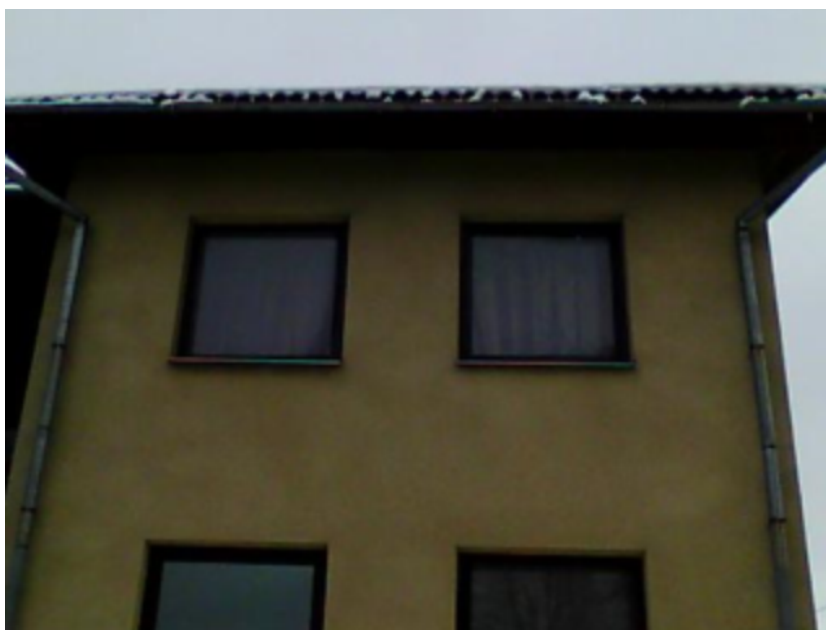
Köögi lagi I korrusel ja Krislini tuba vasakul II korrusel, Ly tuba paremal II korrusel.  
Sp1 Küttev radiaator seina taga.

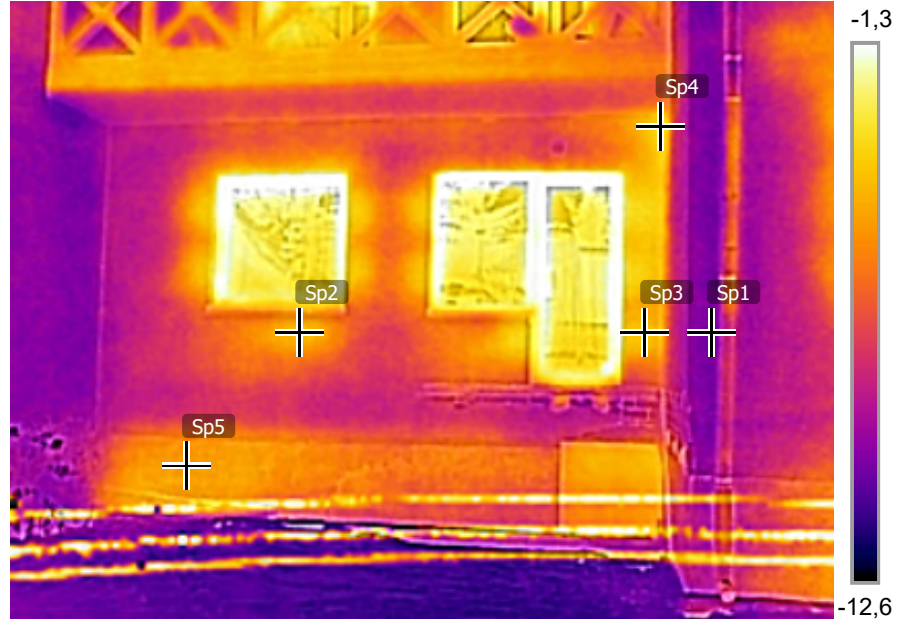
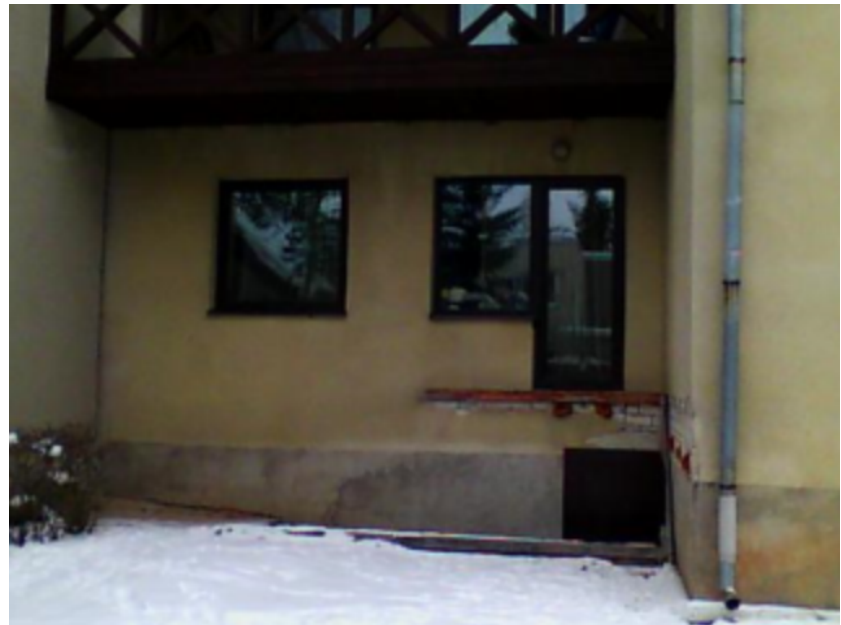
Elutuba I korrusel. Kelder soklis.

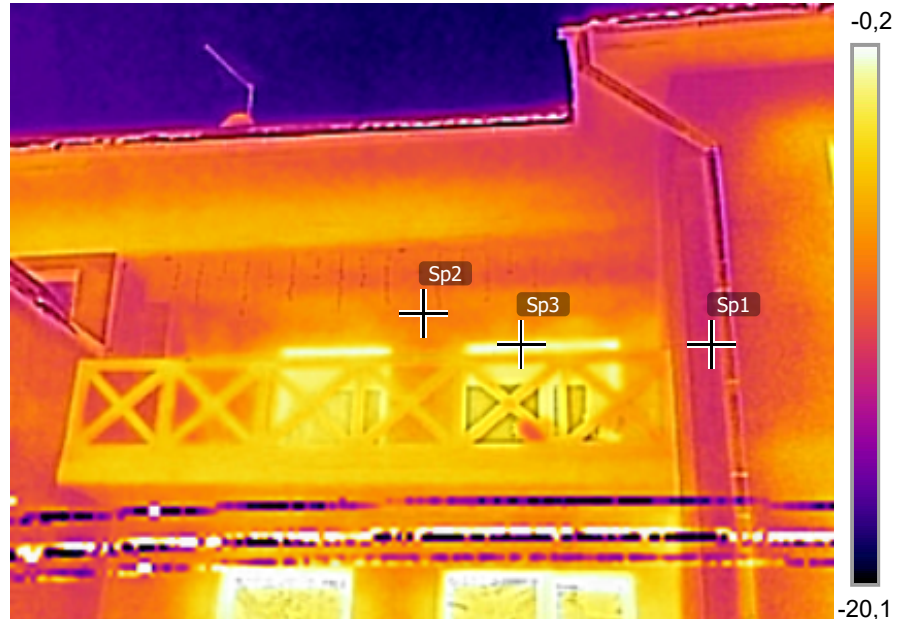
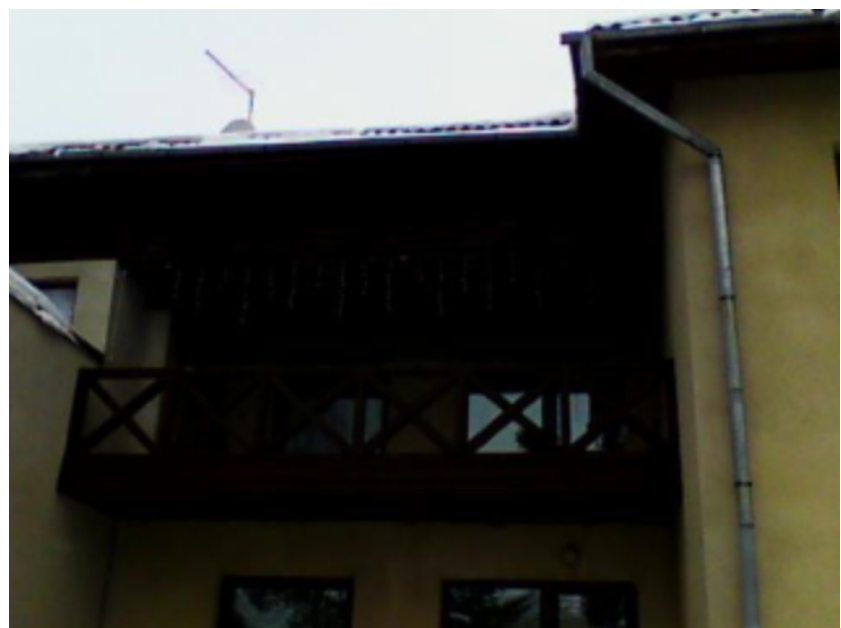
II korruse suur magamistuba. Elutoa lagi.

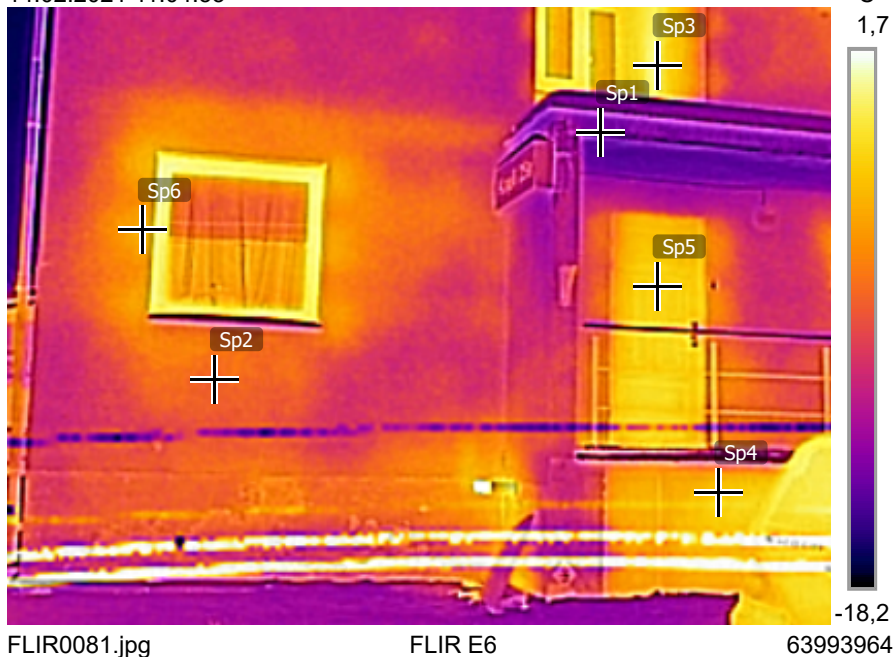
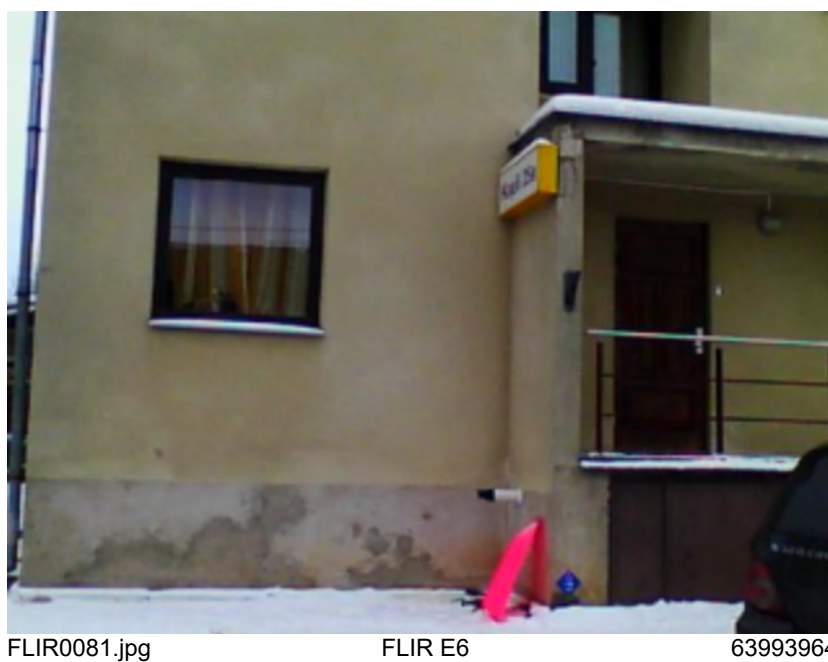
Köögi aken I korrusel, sauna sein sokli vasakus nurgas, sokli paremas servas katlaruumi luuk.  
Sp2 - mitteküttev radiاتور (pealevool maha keeratud).

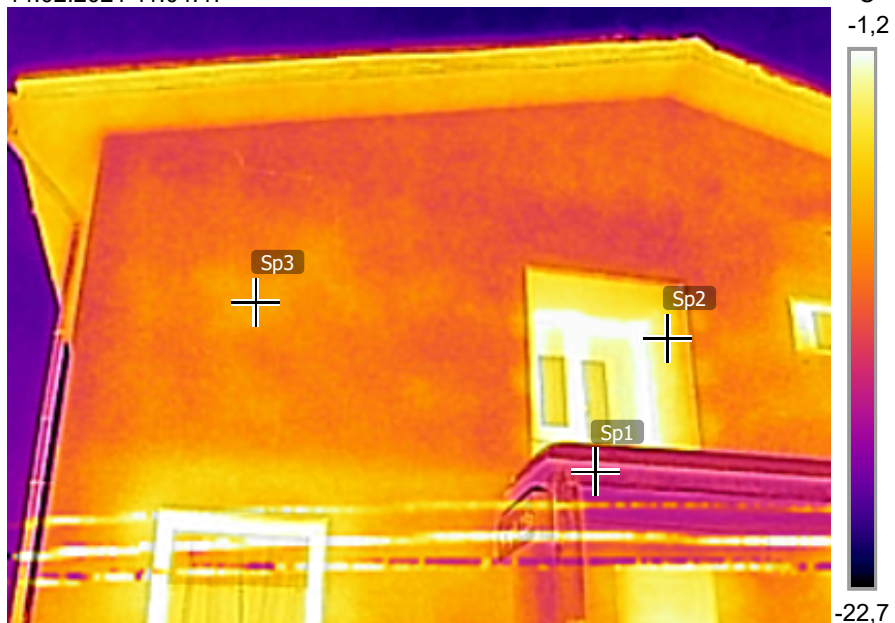
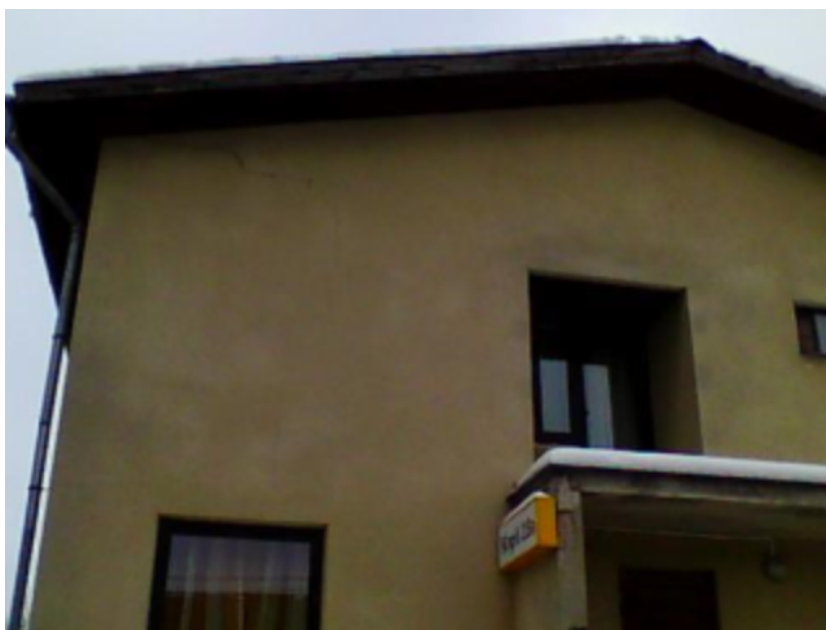
Köögi lagi I korrusel, II korrusel Ly toa sein (ilma küttekehata).

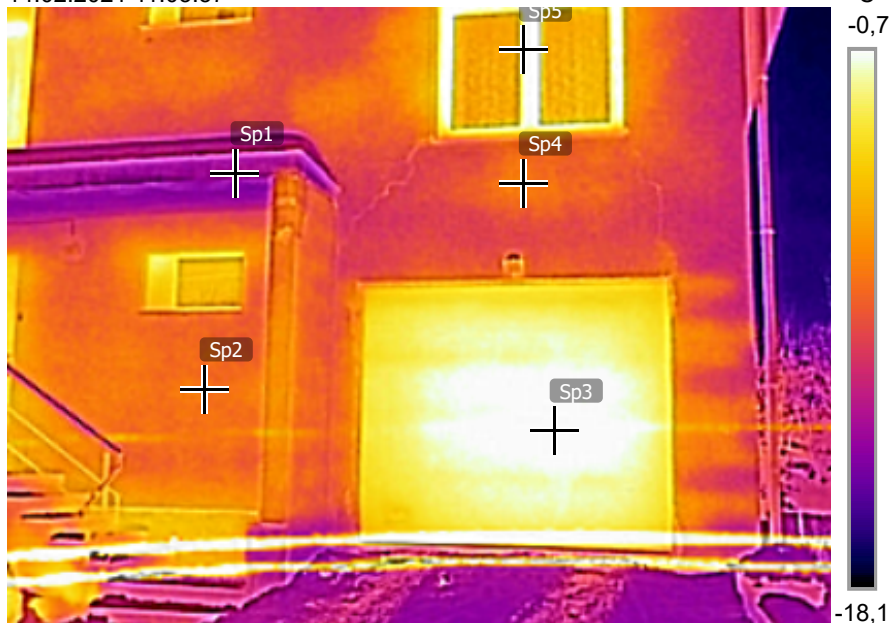
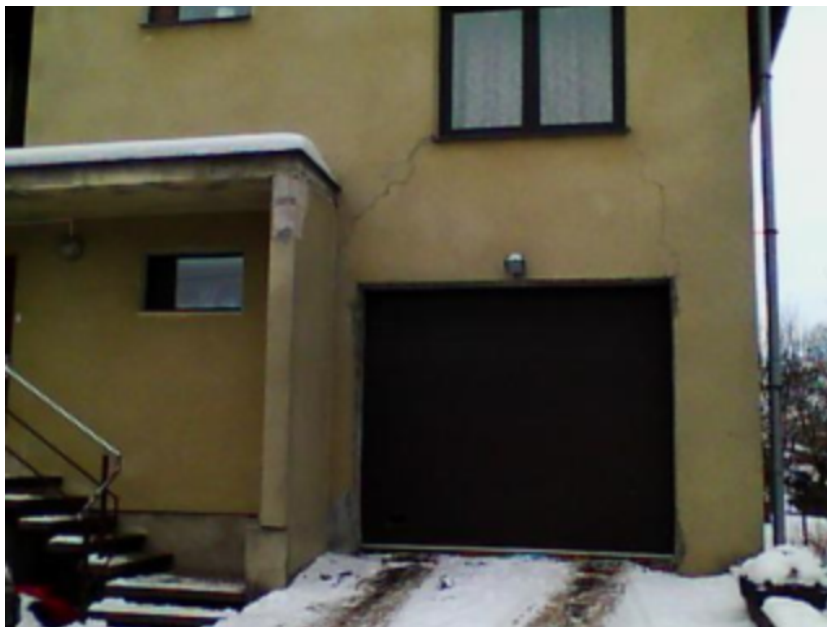
Garaaži uks, Sp4 - radiaator väikesel võimsusel (II aste, IVst).
